Upper Big Branch

The April 5, 2010, explosion: a failure
of basic coal mine safety practices

Report to the Governor
Governor's Independent Investigation Panel

May 2011

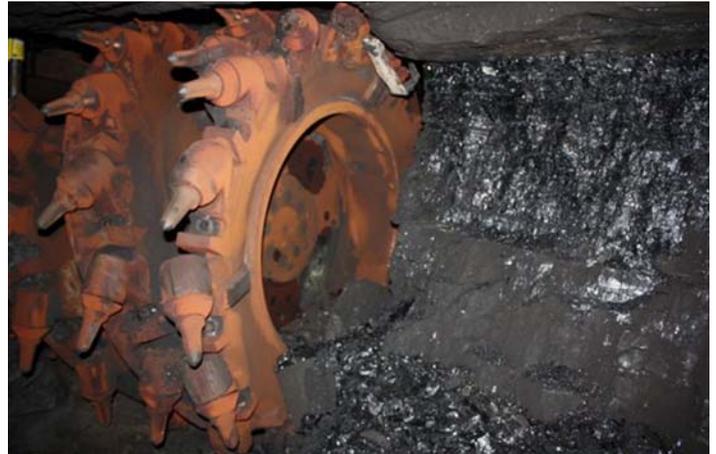
Shearer drum cutting out

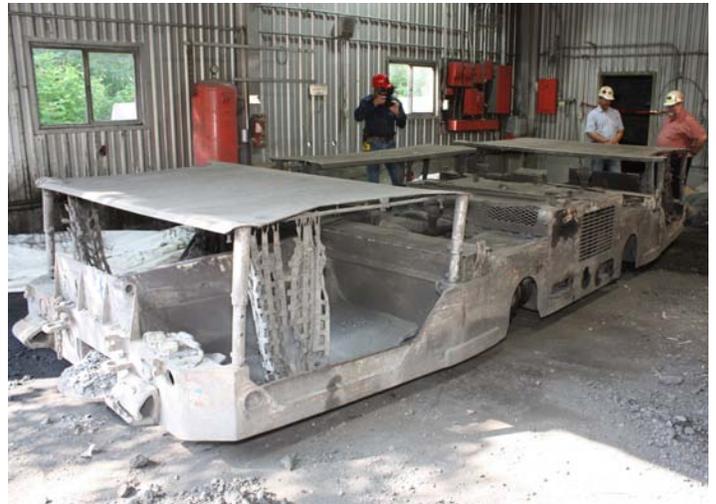
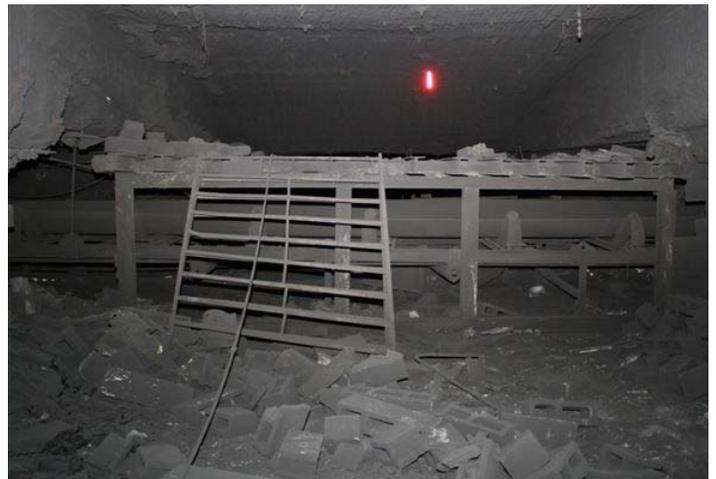
Above, the mantrip in which the Tailgate 22 crew was riding; below, the remains of a cinderblock wall gives an indication of the force of the explosion.

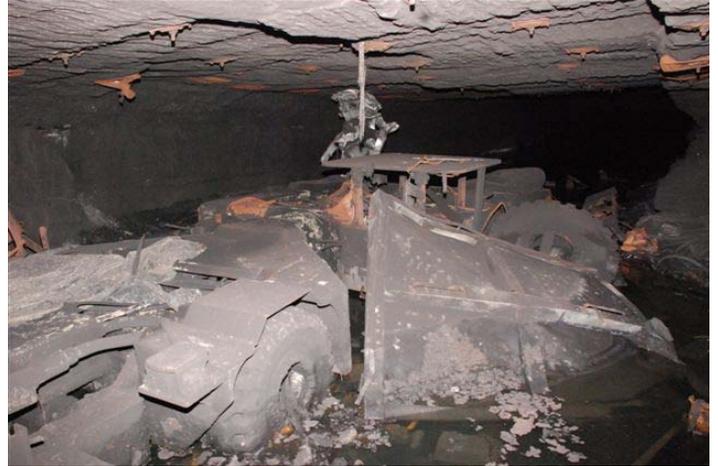
A scoop located on the Headgate 22 section after the April 5 explosion

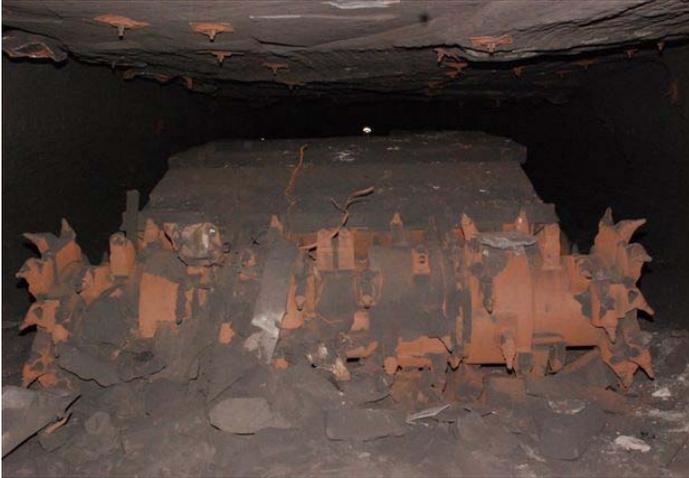
A continuous miner inside the Upper Big Branch mine after the April 5 explosion

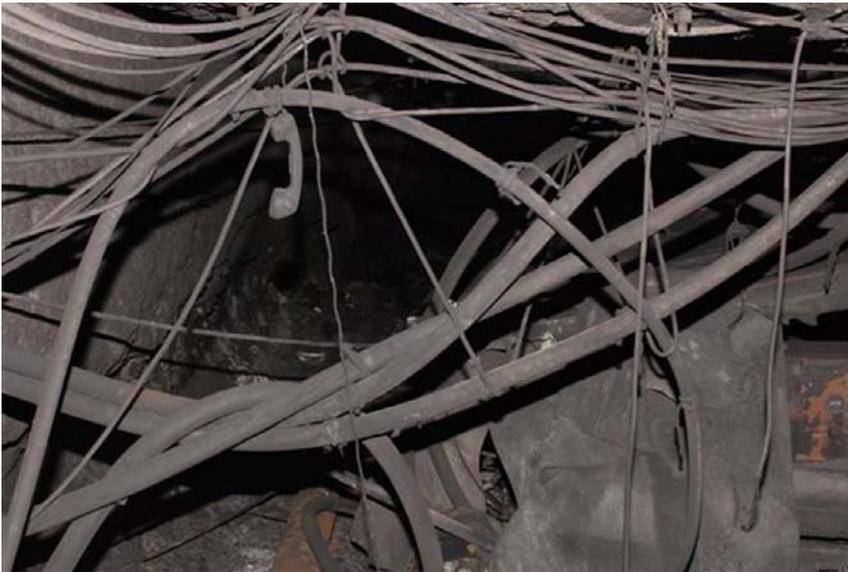
Some of the damage in the UBB mine

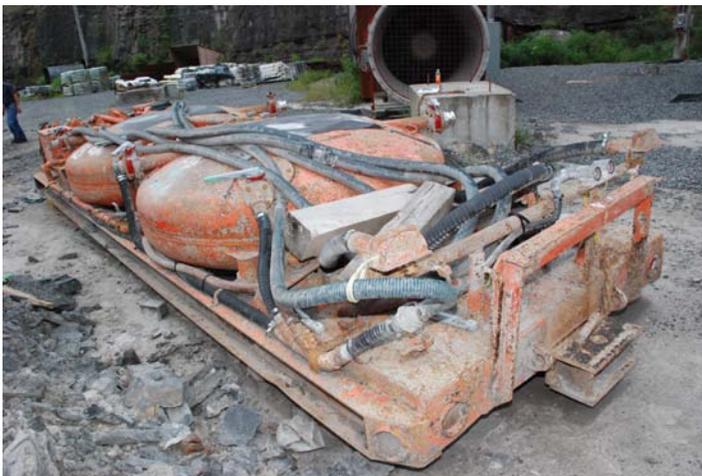
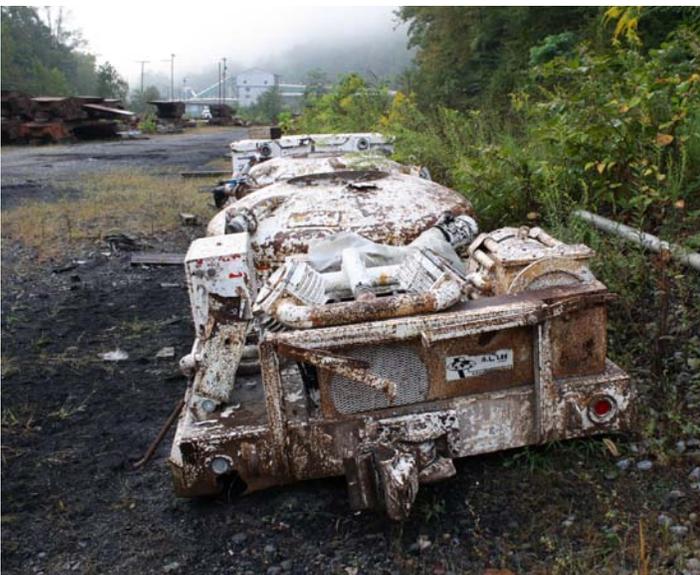
The handwritten notes tell a frustrating story of days in which rock dust couldn’t be applied because the

UBB’s orange pod duster, above, and white rock duster, below

miners ran out of dust, because the men had no motor to run the duster and, most often, because the equipment failed.

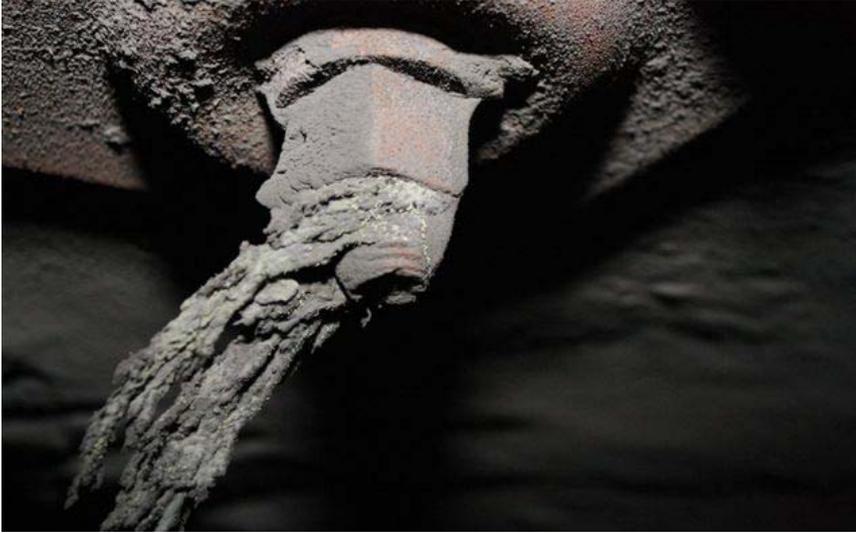
Even at this distance from the point of ignition, the force was great enough to blow two metal canopies

Evidence of the force of the explosion was left in the mine.

off of the section mantrip and hurl them for hundreds of feet in opposite directions. The power of this force suggests an explosion that gained strength and size as it traveled from the longwall tailgate, fueled by coal dust along the way. Analysis of the dust samples taken from Headgate 22 after the explosion also offers evidence that the company was not in compliance with the required rock dusting standards on this section. This inadequate rock dusting allowed coal dust to provide fuel for the explosion to continue to gain force as it traveled in and out of this section of the mine. (see Soot and Coking Map)
